## **Structural Engineering Narrative**

## Renovations to Whitinsville Library, Northbridge, MA

### Preliminary Structural Narrative

December 22, 2025

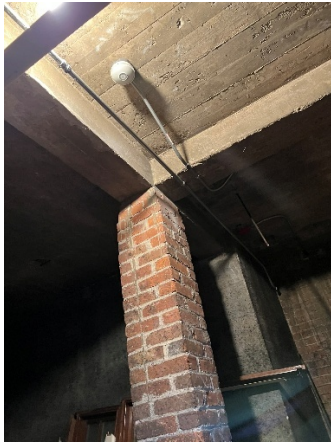
The existing foundations appear to be cast-in-place concrete foundation walls at the exterior, and brick piers and masonry walls in the interior (Photo 1). The lowest floor is assumed to be a concrete slab on grade.

*Photo 1 – Brick pier, concrete and masonry wall beyond, concrete beam and flat slab*

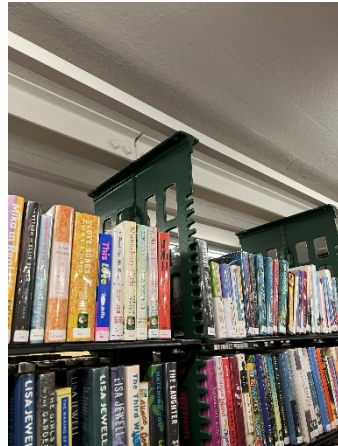
The elevated first and second floor levels appear to be concrete flat slabs with concrete beams in most of the historic portion. The stack area is a two-story structural stack system where the shelving units also support the floors between and around the shelves. (Photos 2 and 3) The small addition appears to be a concrete slab on deck supported on load bearing masonry walls with strategic use of steel angle for additional support. (Photo 4) Since the original floor to floor heights are relatively small, and the existing floor systems are thin, available depth of structure at the addition was also limited.

*Photo 2 – Structural shelving system supporting floor*

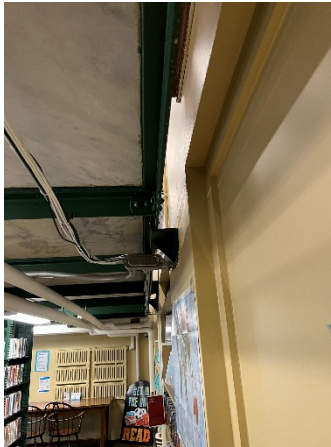
*Photo 3 – Floor system at stacks supported at exterior wall*

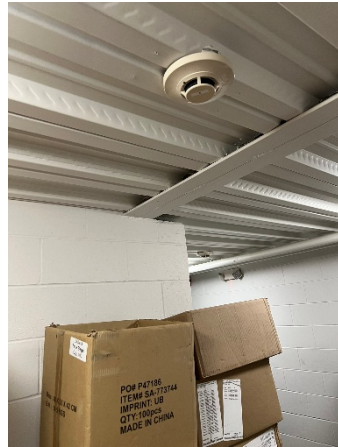
*Photo 4 – Structural floor system at addition*

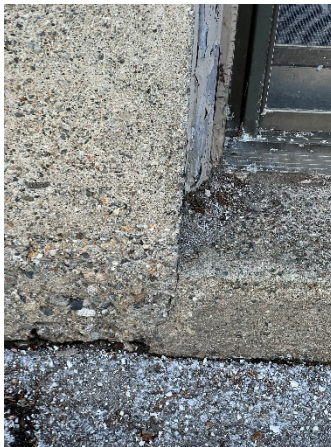
- Minimal cracking near in the concrete foundation wall near a window (photo 5). No signs of water infiltration, so no further action required.
- Failed gutter at the inside, northwest corner (Photo 6) causing staining on the concrete (Photo 7). Gutter should be repaired to avoid potential water damage.

*Photo 5 – Cracking in concrete foundation wall*

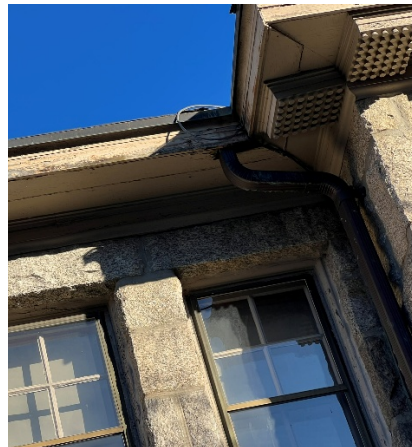
*Photo 6 – Failed Gutter*

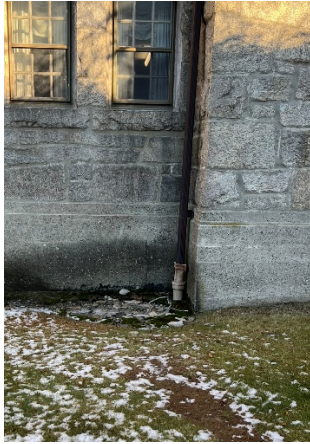
*Photo 7 – Water staining below damaged gutter*

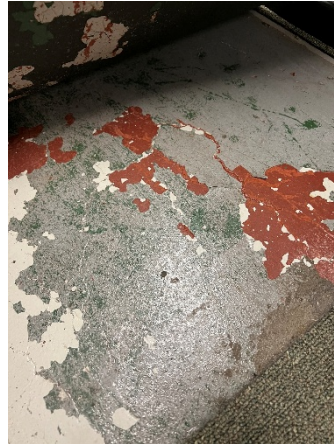
- The subfloor below the carpet tiles in the lower stack area has buckled in some places causing tripping hazards. (Photo 8) This should be addressed by removing and replacing the sub floor locally. The moisture should also be mitigated for a long term repair.

*Photo 8 – Buckling in subfloor*

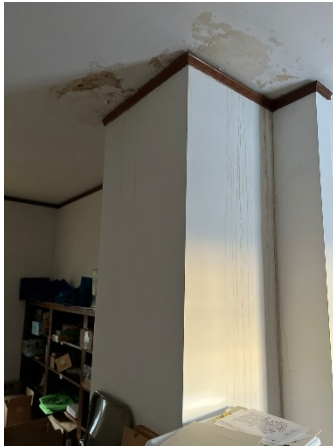
- Around one of the chimneys, there are indications of water infiltration. Flashing around the chimney should be reviewed and repaired as needed. (Photo 9)

*Photo 10 – Water damage at chimney penetration through roof*
